Multi-Layer Media Solves Plugging and Pressure Drop Problems. Saves \$100,000 per Year Over Five Years Operating Experience at Hatfield WWTP

Hatfield WWTP RTO Retrofit Results

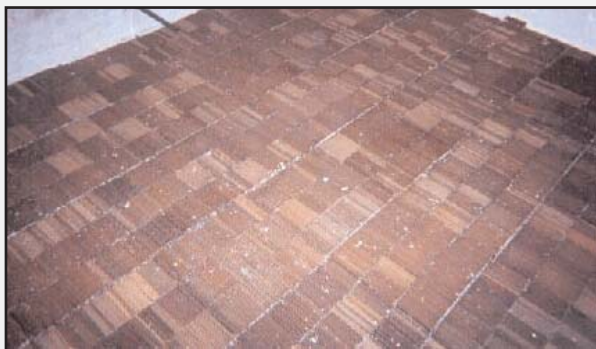
Comparison: Five year old saddles vs. Five year old MLM

MLM installed August 1996. Photo taken 2002²

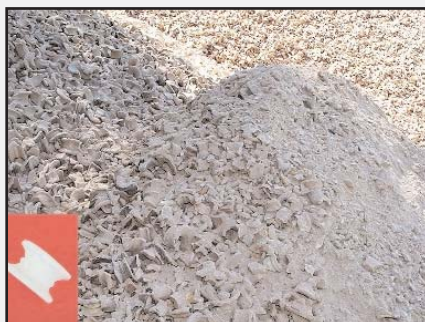
New Saddle (Insert) contrasted with Saddles after five years RTO service¹

As previously mentioned, when the RTO contained saddles, the pressure drop over time was observed to 'creep' upward despite frequent washing. This is a common phenomenon of saddles and other random dump heat recovery medias.
