# LANTEC

## *MLM<sup>®</sup> vs. Conventional RTO Heat Recovery Media*

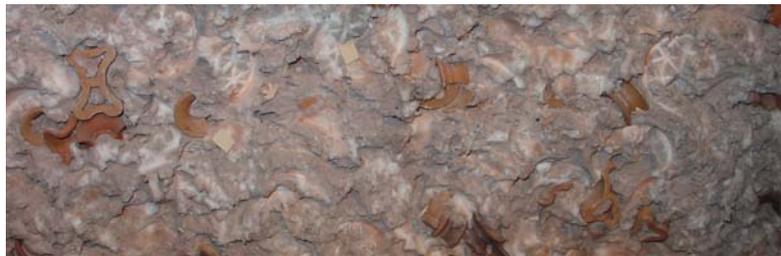
Note that several types of random media have been tried in this RTO, and have been preserved in the insulation.

Random media, in addition to high pressure drop, are also associated with common operational problems when used as the heat recovery media in RTO units. These problems include settling and nesting which leads to even higher pressure drop (and hence higher operating expenses), as well as degradation over time.

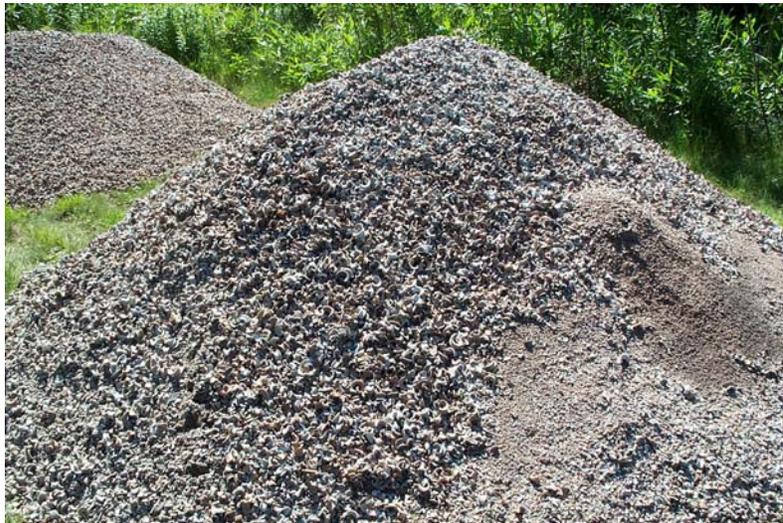
Photo supplied courtesy of the city of Fitchburg, MA. These saddles were removed from their RTO to allow for retrofit to MLM<sup>®</sup>. Note some of the saddles had been ground to the consistency of sand. See case study [www.lantecp.com/casestudy/casestudy36.html](http://www.lantecp.com/casestudy/casestudy36.html).

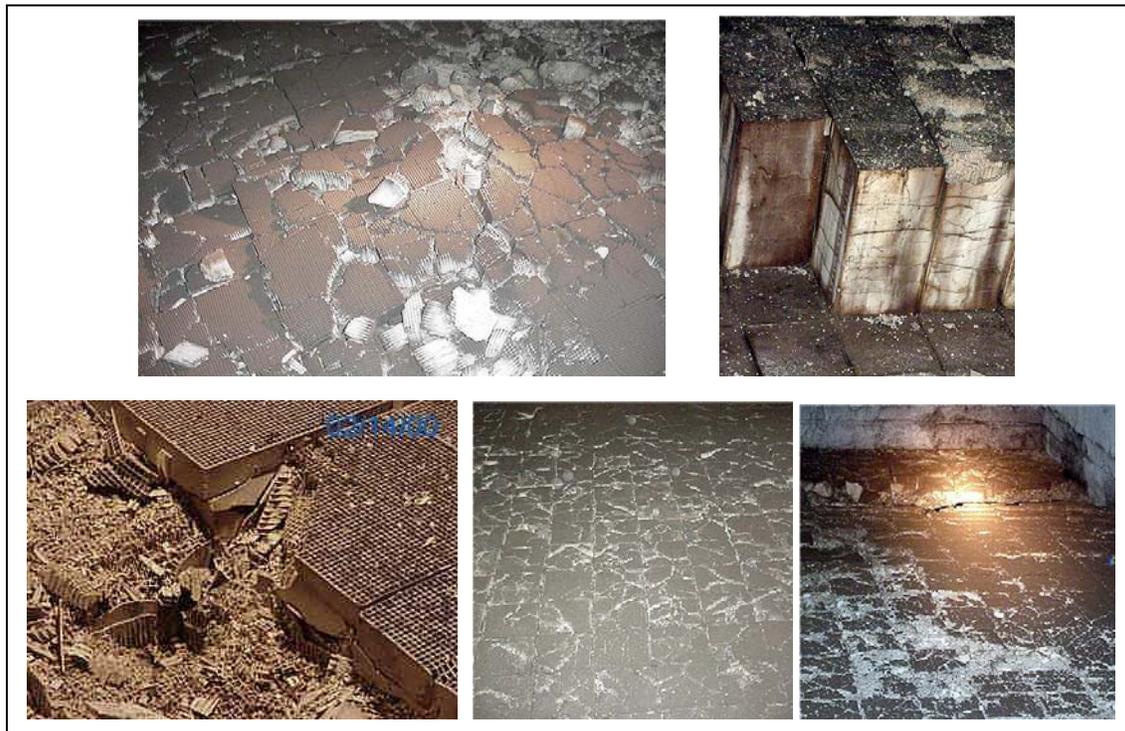
Monolith media has proven to be very susceptible to catastrophic damage due to thermal stress always present within any RTO. The following three photos are from several different RTO units.

The heat recovery media within a RTO is subject to extreme fluctuations in temperature. This phenomenon is most pronounced in the central portion of the heat recovery beds. Note the temperature profile during a typical RTO heating and cooling cycle.

Note that temperature variation of  $\sim 300+$  °F (150 °C) is expected within this bed. And this variation takes place during each heating and cooling cycle.

Additionally, normal design practice for a RTO unit assumes that all combustion of organic compounds takes place within the combustion chamber. No combustion of organics is assumed to take place within the heat recovery media. But in reality, with temperatures of 1000+ °F within the heat recovery media, combustion of organics within the heat recovery media is a normal occurrence.

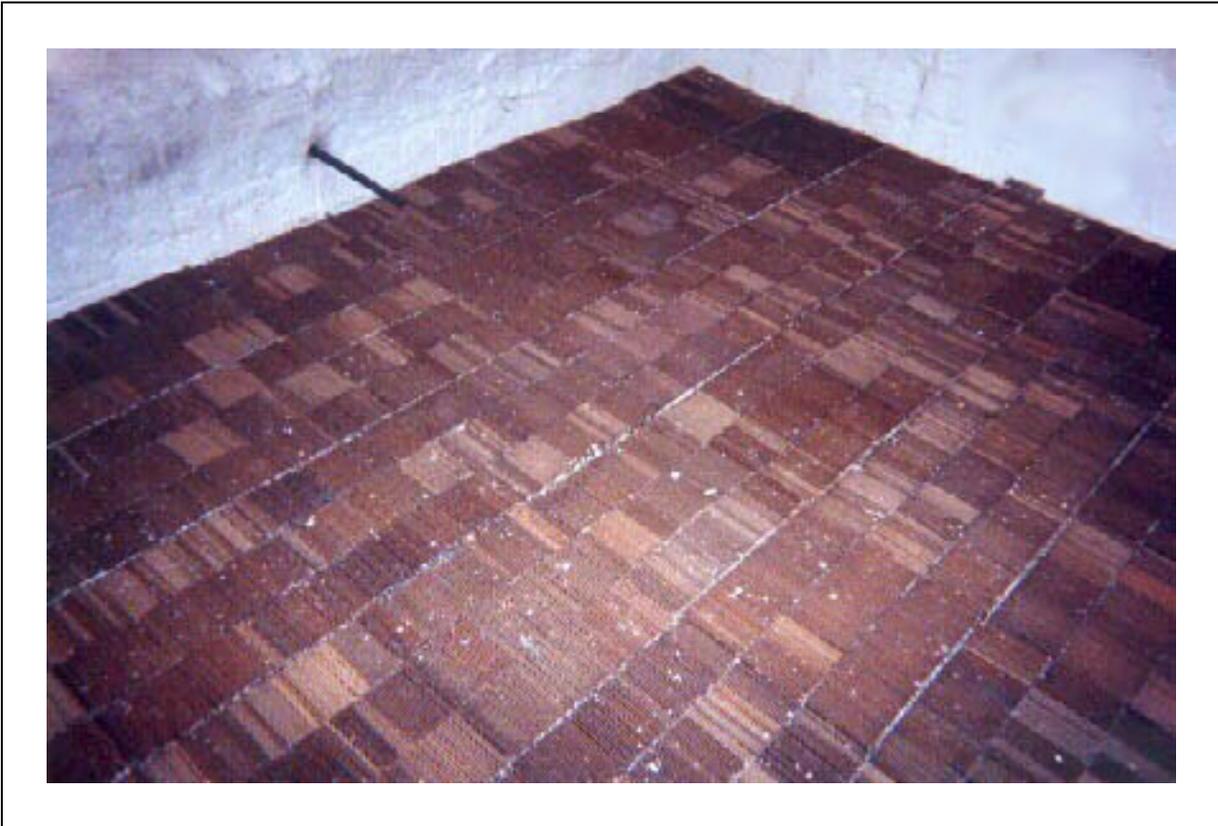
The following photo shows the first installed bed of MLM<sup>®</sup> within a RTO. This media is performing today as it was when first installed in 1996. To date, no MLM<sup>®</sup> media has been replaced due to the types of failures of saddles and monolith noted here so long as the MLM<sup>®</sup> was installed per the instructions of Lantec Products and the RTO operated per the design parameters provided to Lantec Products.
