## CASE HISTORY 10 — LANPAC®

# Methanol Recovery Doubled After Pall Rings Replaced

Feed rate doubled, flooding eliminated, and BOD permit violation resolved after replacing 2" Pall rings with LANPAC 3.5".

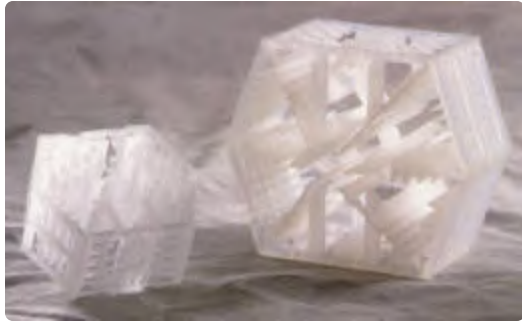
*2.3" Lanpac and 3.5" Lanpac*

The plant's process engineering group called upon Lantec to find a cost-effective solution. Process parameters were reviewed, including the expected top and bottom concentrations in the column. Lantec recommended LANPAC 3.5" media, and the recommendation was accepted.

The results exceeded expectations. Feed rate was doubled, pressure drop through the tower decreased, and mass transfer efficiency increased. More methanol is being recovered and returned to the process stream. With no further need to bypass the distillation column, the BOD effluent returned to below permitted discharge limits. Production costs were reduced and a major environmental compliance problem was avoided.
